# Inventory & Schedule of Condition

Property inspected by Gabriella Button-Stephens

2 Harveys Corner  
Pond Lanes End  
Redruth  
Cornwall  
TR15 1BD

**June**  
**25th 2020**  
11:15

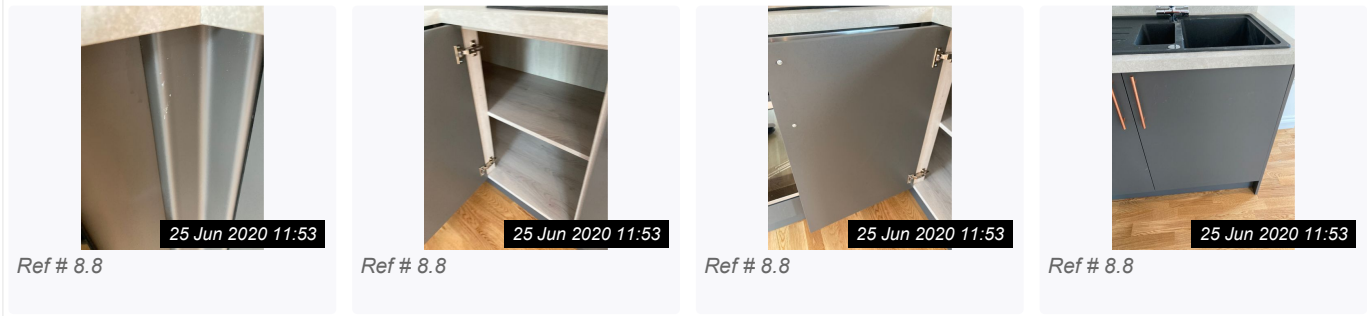
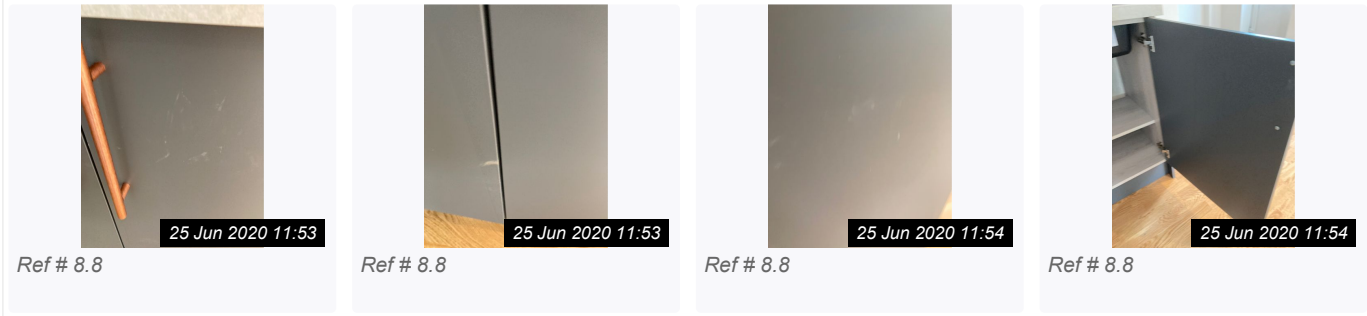
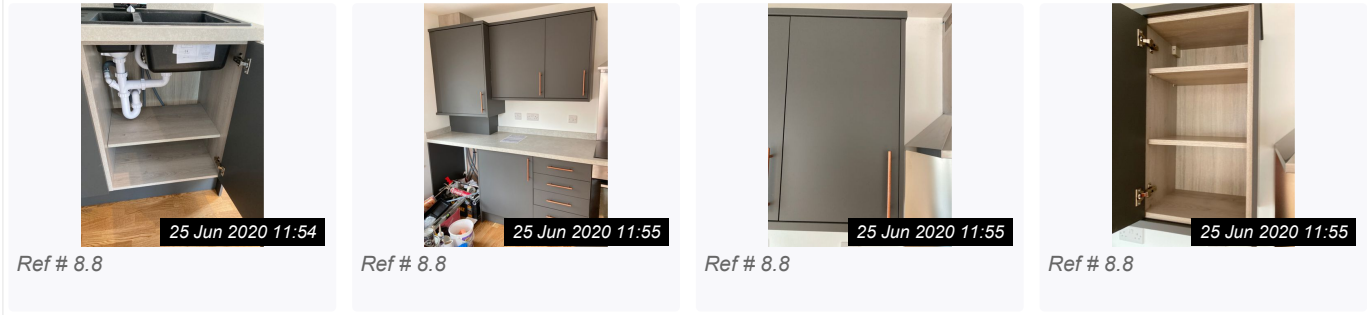
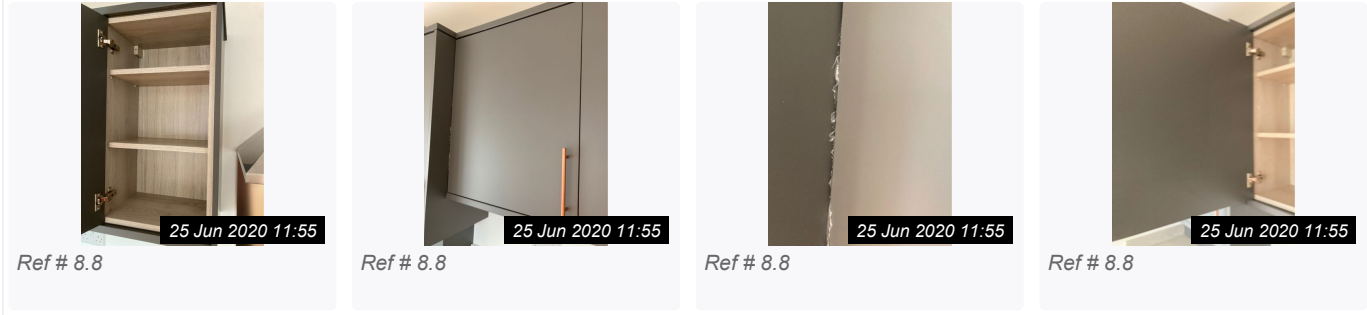
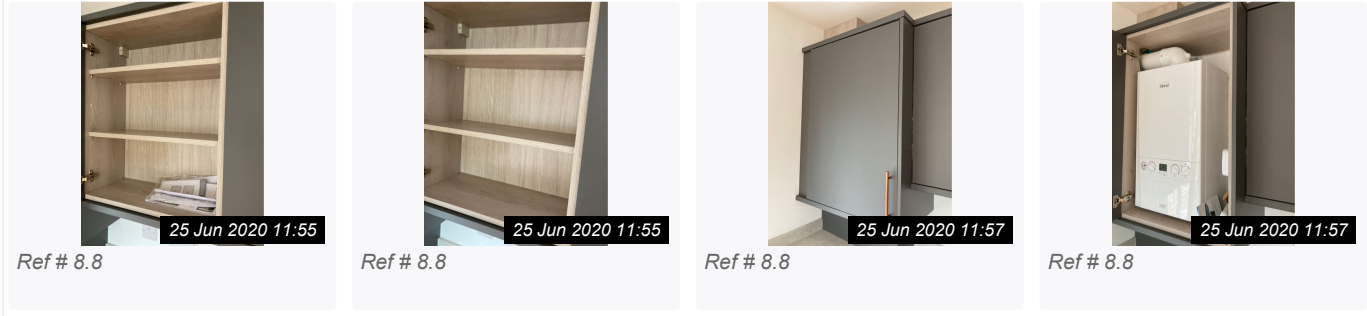
| 8. KITCHEN (CONT.) | | | |
|---|---|---|---|
| 8.8 Kitchen units | Grey units with glittered copper effect handles and wood design interiors. ; Contains built in fridge and boiler cupboard.; Architrave; | As New, fingerprints, some builders dust - appears to wipe off. 5 small white dots/marks in corner by oven. Some dust by boiler | |
